EFRE 2020

Marks on Single-Crystal Copper Cathodes after Short-Pulse Voltage Impact on Vacuum Gaps

Evgeny Nefedtsev , Sergey Onischenko,
Institute of High Current Electronics SB RAS
2/3 Academichesky Ave., 634055, Tomsk, Russia

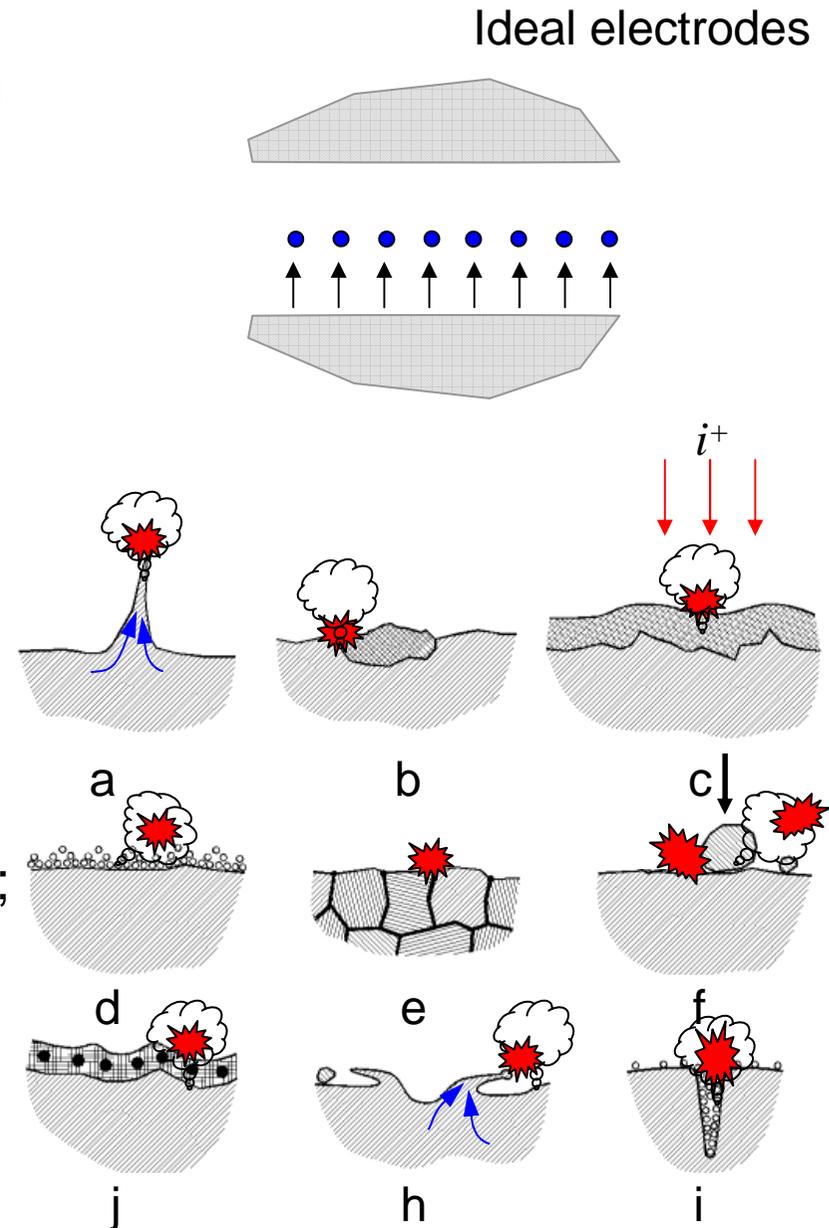
- Theoretical electric strength of vacuum insulation $E_{lim} \sim 3 \text{ GV/m}$
- Real electric strength of mm-cm vacuum gaps (VG) $E_{br} < 0.1 \text{ GV/m}$
- Various types of inhomogeneities that lead to breakdown of VGs:

- (a) – micro-protrusions;
- (b) – dielectric inclusions;
- (c) – oxide films;
- (d) – layers of adsorbed gas;
- (e) – outcrops of intergranular boundaries;
- (f) – polyatomic particles;
- (g) – products of oil vapors;
- (h) – edges of craters from previous breakdowns;
- (i) – pores and cracks.

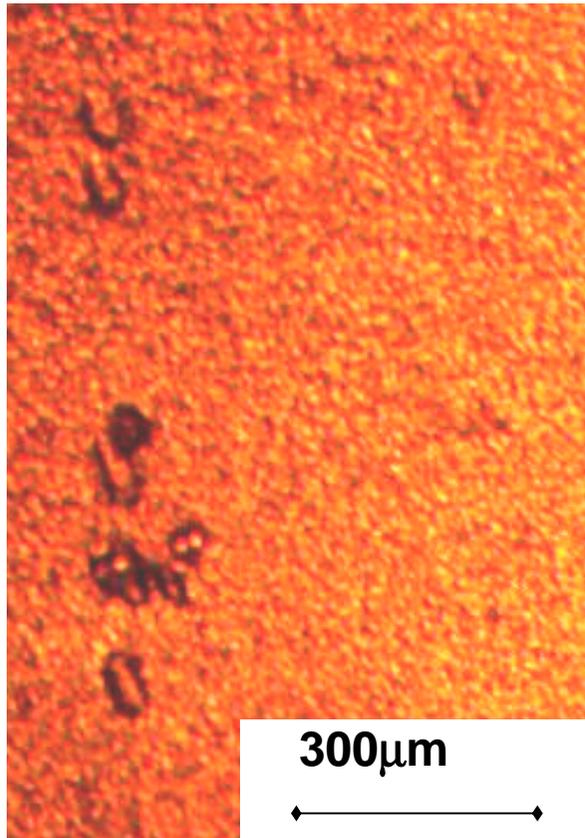
surface (110)

Etching pits on dislocations outcrops

(10 gm $(\text{NH}_4)_2\text{S}_2\text{O}_8$ + 10 ml H_2O_2 + 50 ml H_2O)

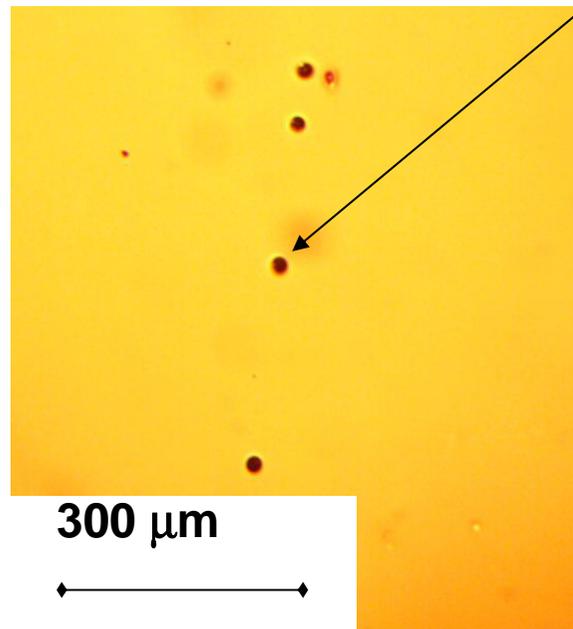
Optical image

Electrolytic polishing of copper surface (state before vacuum spark)

Marks of dislocations outcrops after polishing

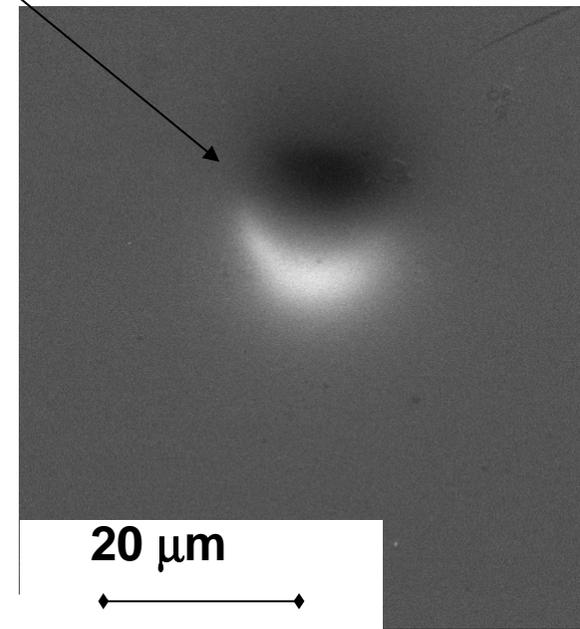
Electronic image

H_3PO_4 saturated with Cu^{2+} ions

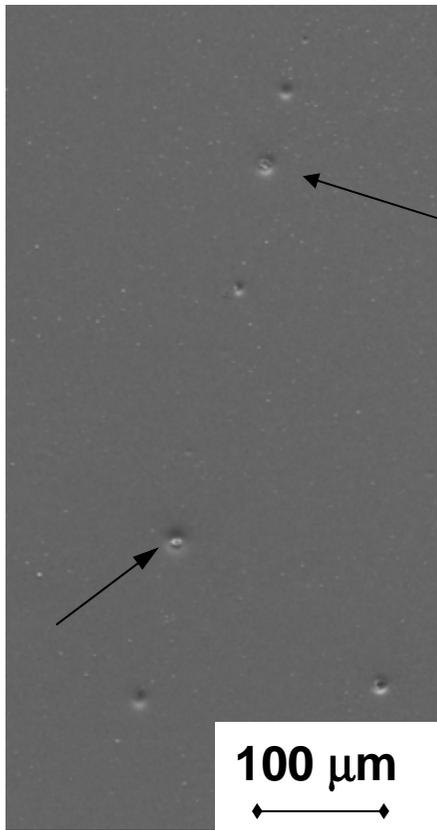
Marks after "high current" treatment

Micron erosion centers

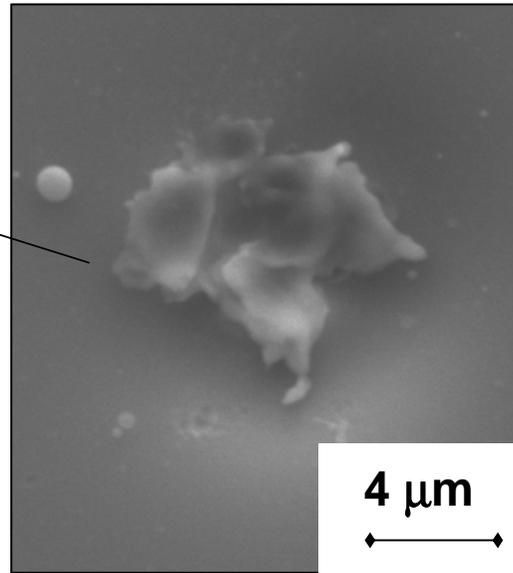
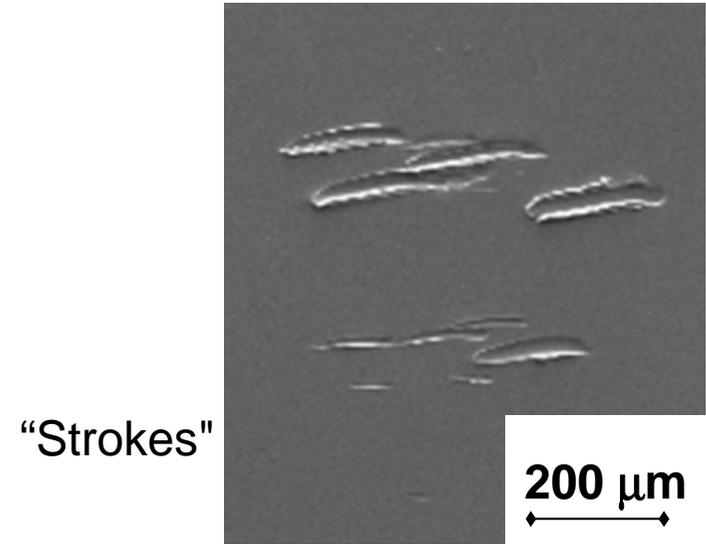
"Strokes"

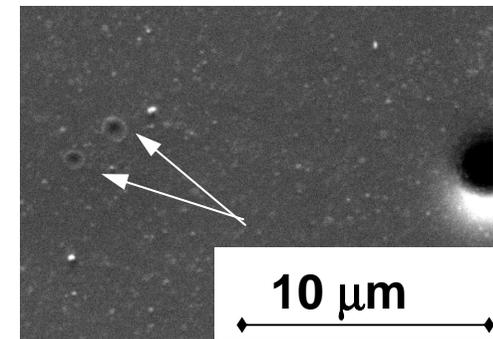
Submicron erosion centers

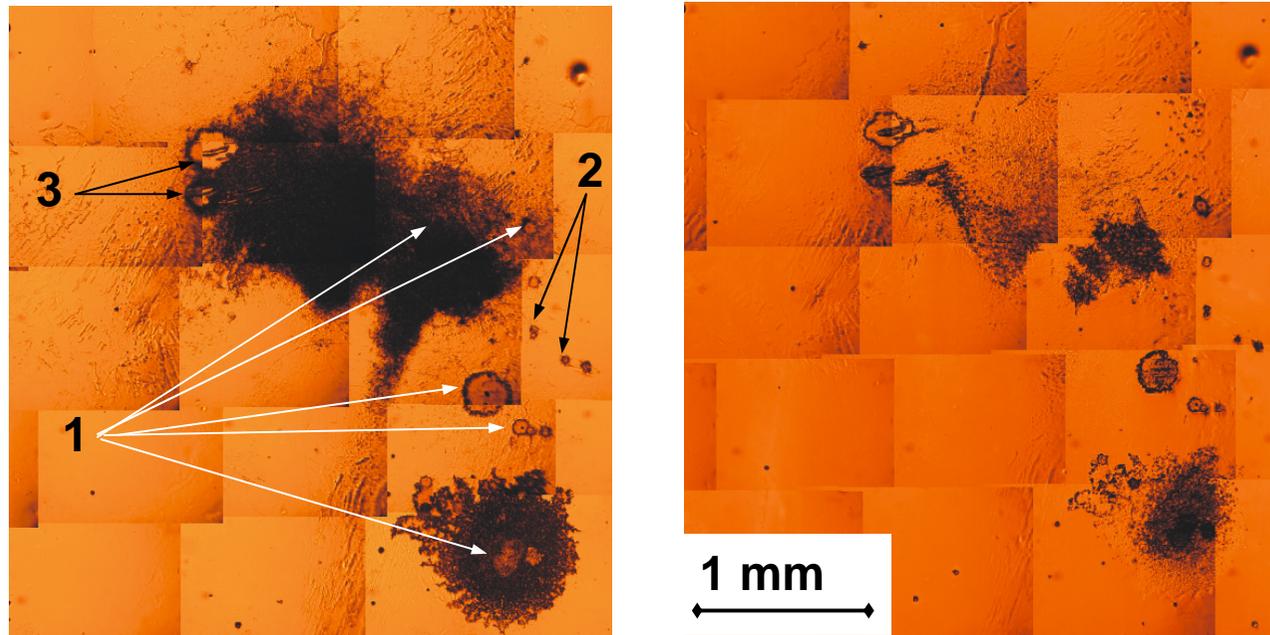
Etching after "high current" treatment

Spark traces which revealed by etching :

- 1 - erosion centers which coincided with original dislocations
- 2 - submicron erosion centers,
- 3 - "strokes".

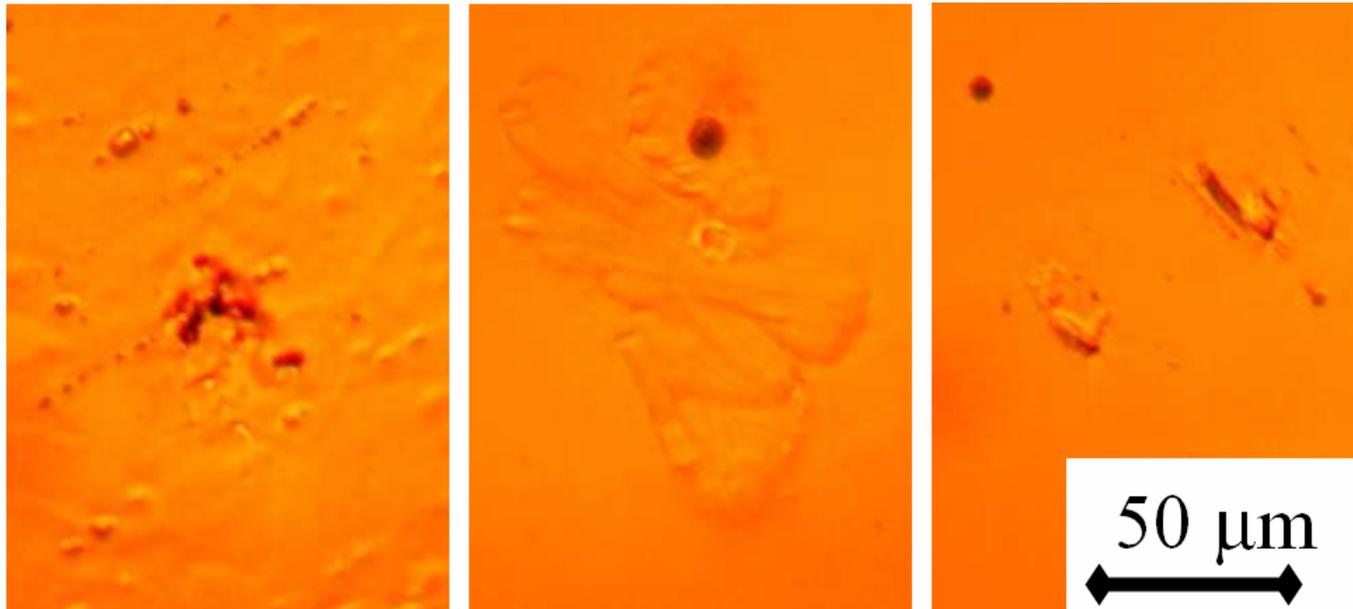
Marks after “low current” treatment

Polycrystalline (with etching)

(110) surface

(111) surface

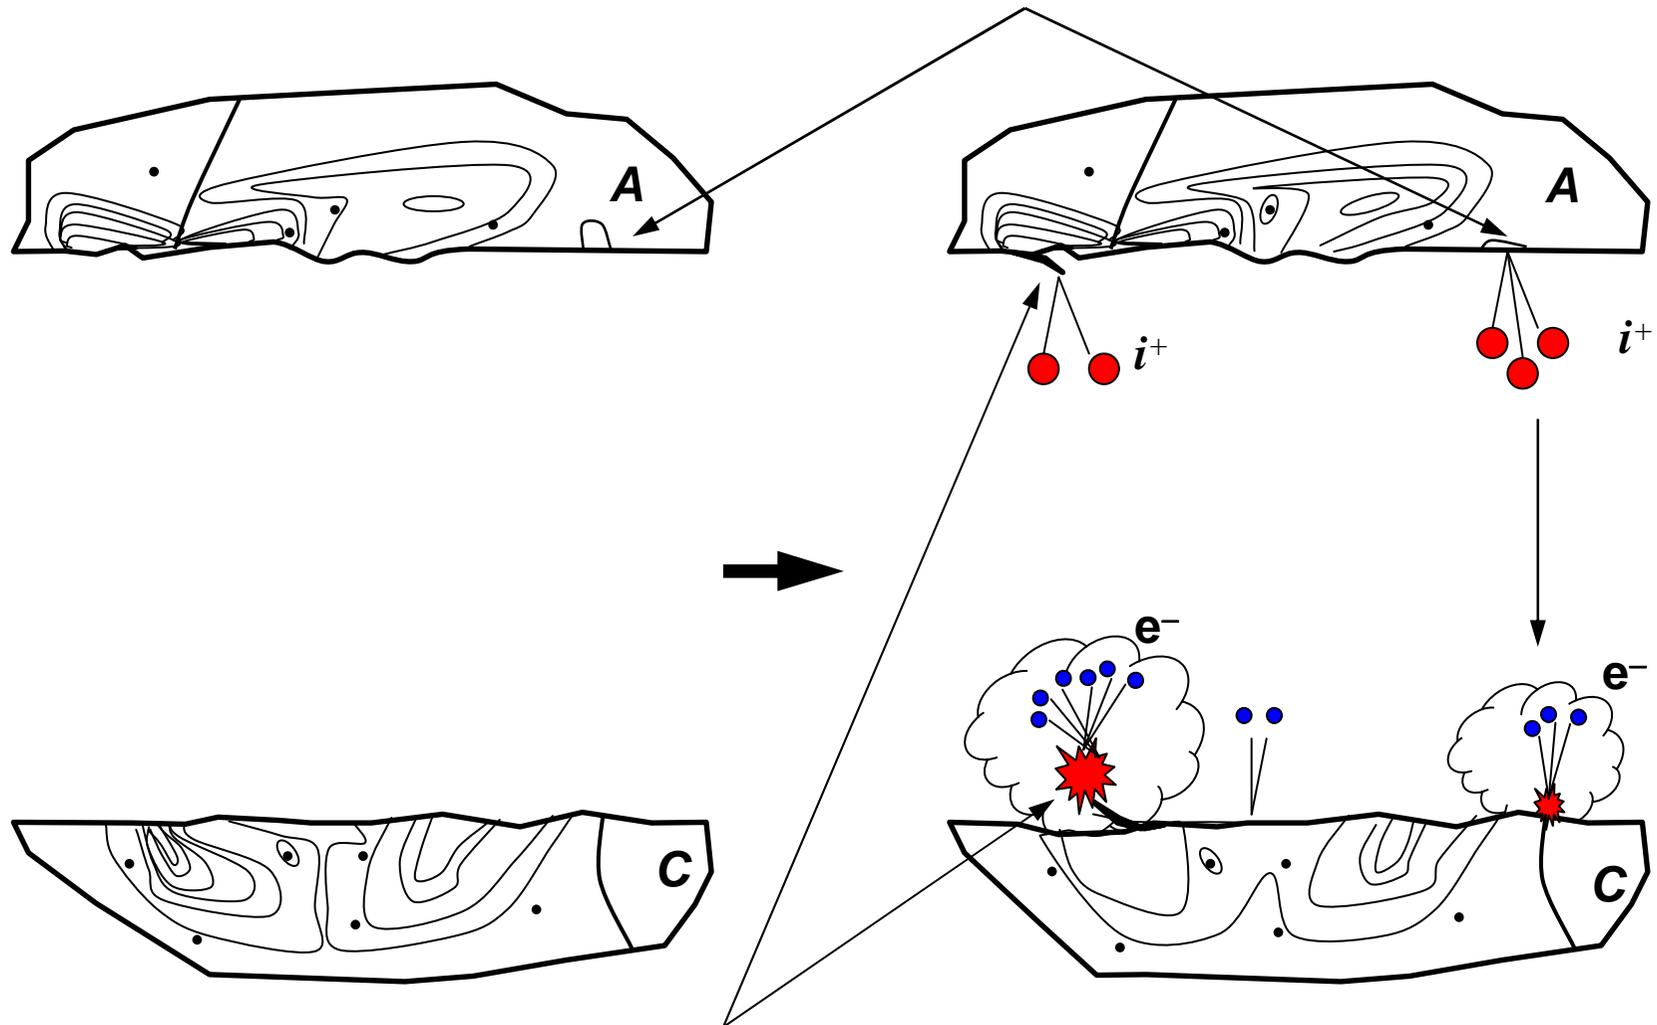
Unstable dislocation half-loop as a source of ion emission at anode

Embrittlement and exfoliation of the material
